-- 1 OF 1 \*\*\*DTIC DOES NOT HAVE THIS ITEM\*\*\*  
--  
-- 1 - AD NUMBER: D432682  
-- 5 - CORPORATE AUTHOR: BOEING CO SEATTLE WA BOEING MARINE SYSTEMS  
-- 6 - UNCLASSIFIED TITLE: DEVELOPMENT OF AN ADVANCED COMPOSITE  
-- HYDROFOIL FLAP,  
-- 9 - DESCRIPTIVE NOTE: FINAL REPORT,  
--10 - PERSONAL AUTHORS: OKEN,S. ;  
--11 - REPORT DATE: , 1979  
--12 - PAGINATION: 138P  
--14 - REPORT NUMBER: D321-51319-1  
--15 - CONTRACT NUMBER: N00024-76-C-4233  
--20 - REPORT CLASSIFICATION: UNCLASSIFIED  
--22 - LIMITATIONS (ALPHA): APPROVED FOR PUBLIC RELEASE; DISTRIBUTION  
-- UNLIMITED. AVAILABILITY: NAVAL SUPPLY SYSTEMS COMMAND, WASHINGTON,  
-- D. C. 20362.  
--33 - LIMITATION CODES: 1 24

FIGURE 1-1 PATROL CRAFT HYDROFOIL (PCH-1) - COMPOSITE FLAP

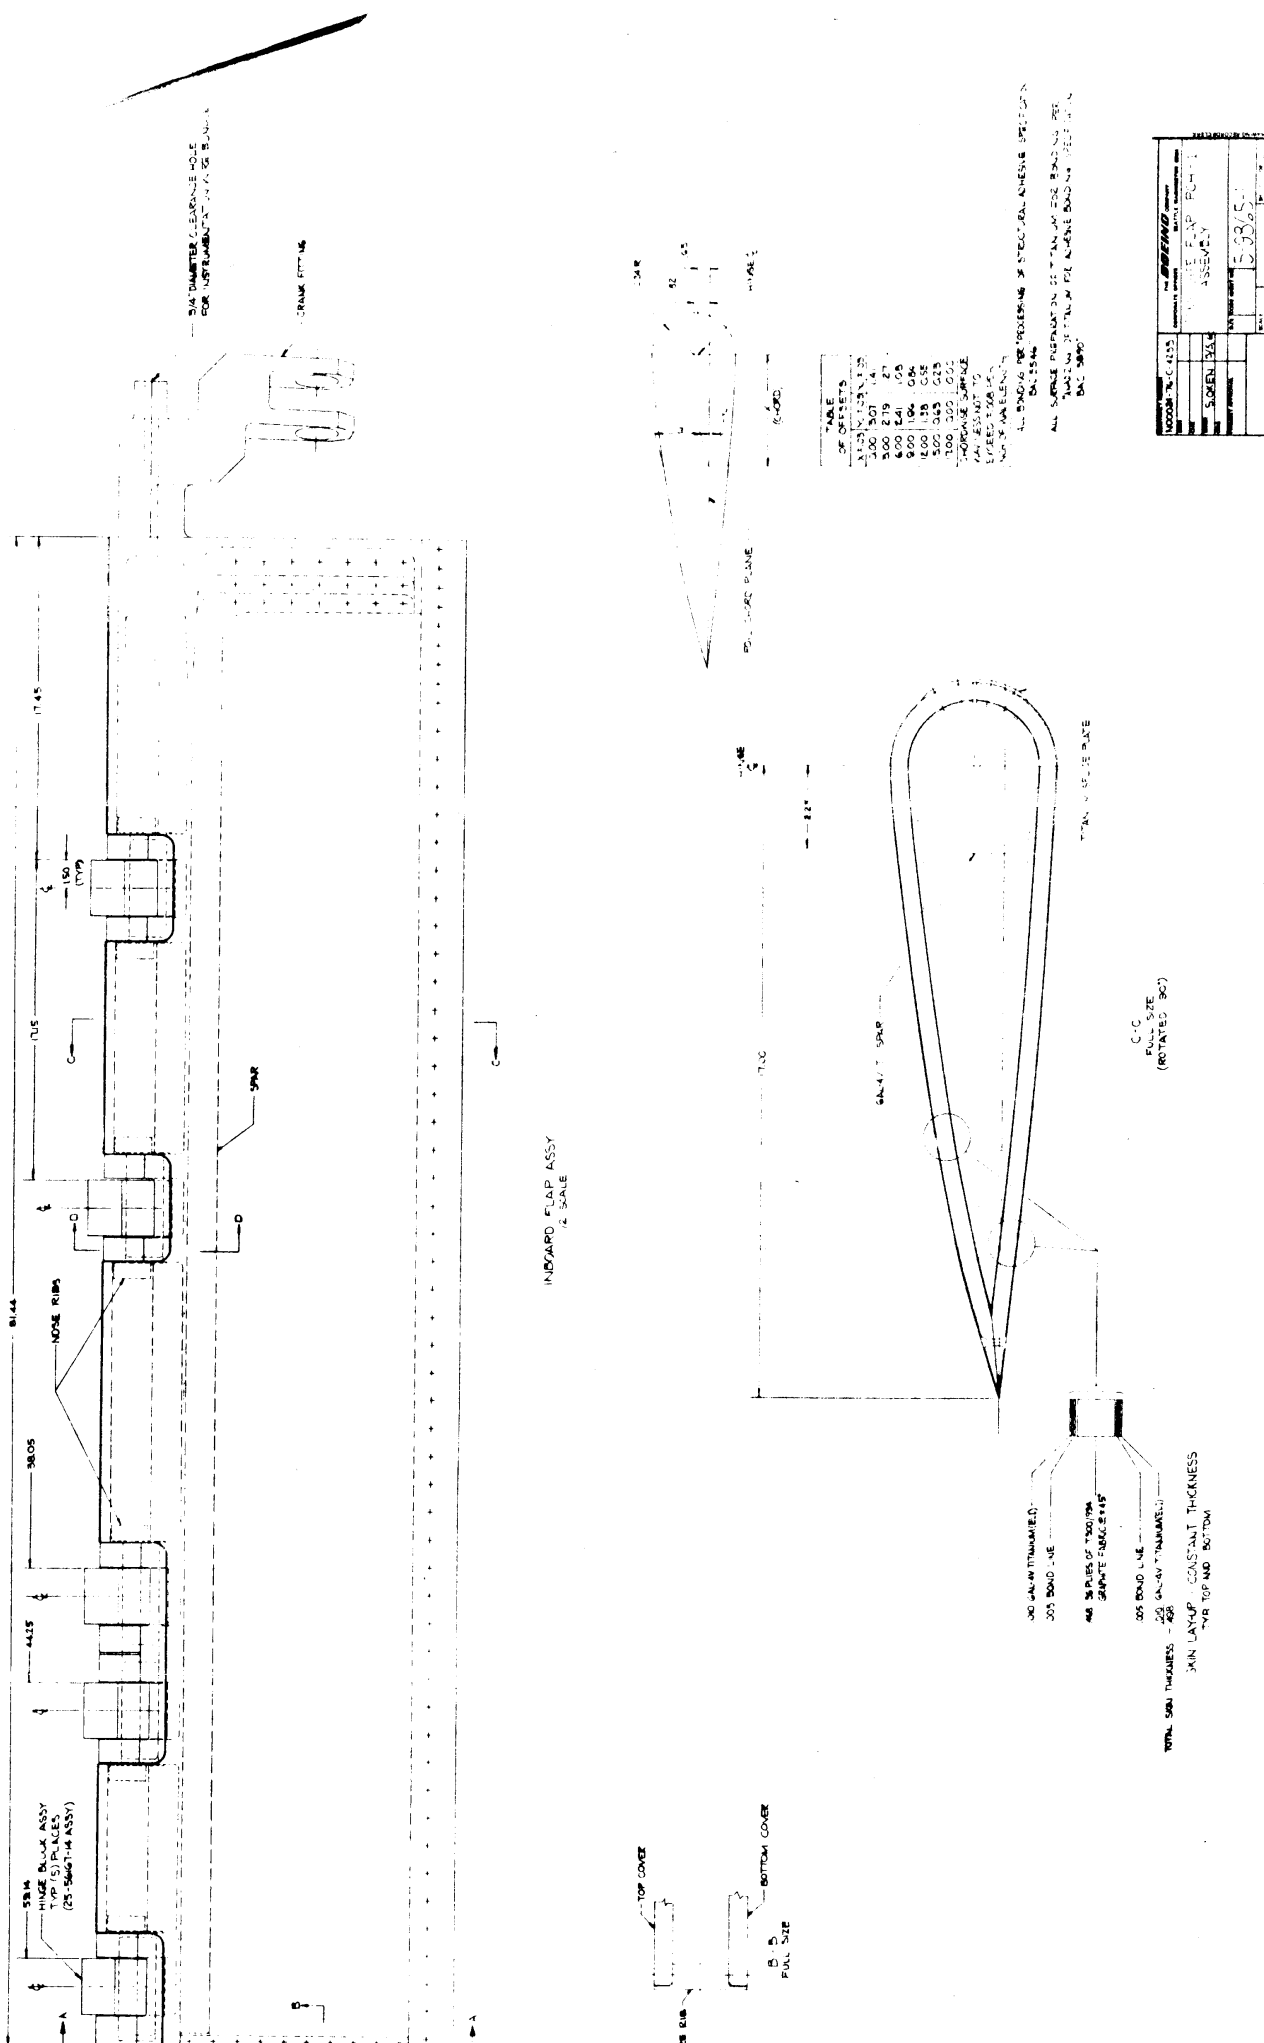
FIGURE 3-1b COMPOSITE FLAP PCH-1 ASSEMBLY (5-9865-1 SHEET 2)

B-B  
FULL SIZE  
ROTATED 90°  
TYPICAL 9 PLACES

TYPICAL SINE CROSS-SECTION  
 ROTATED 90°  
 FULL SIZE  
 A-Y

SPAR - CRANK ASSY   
1/2 SIZE

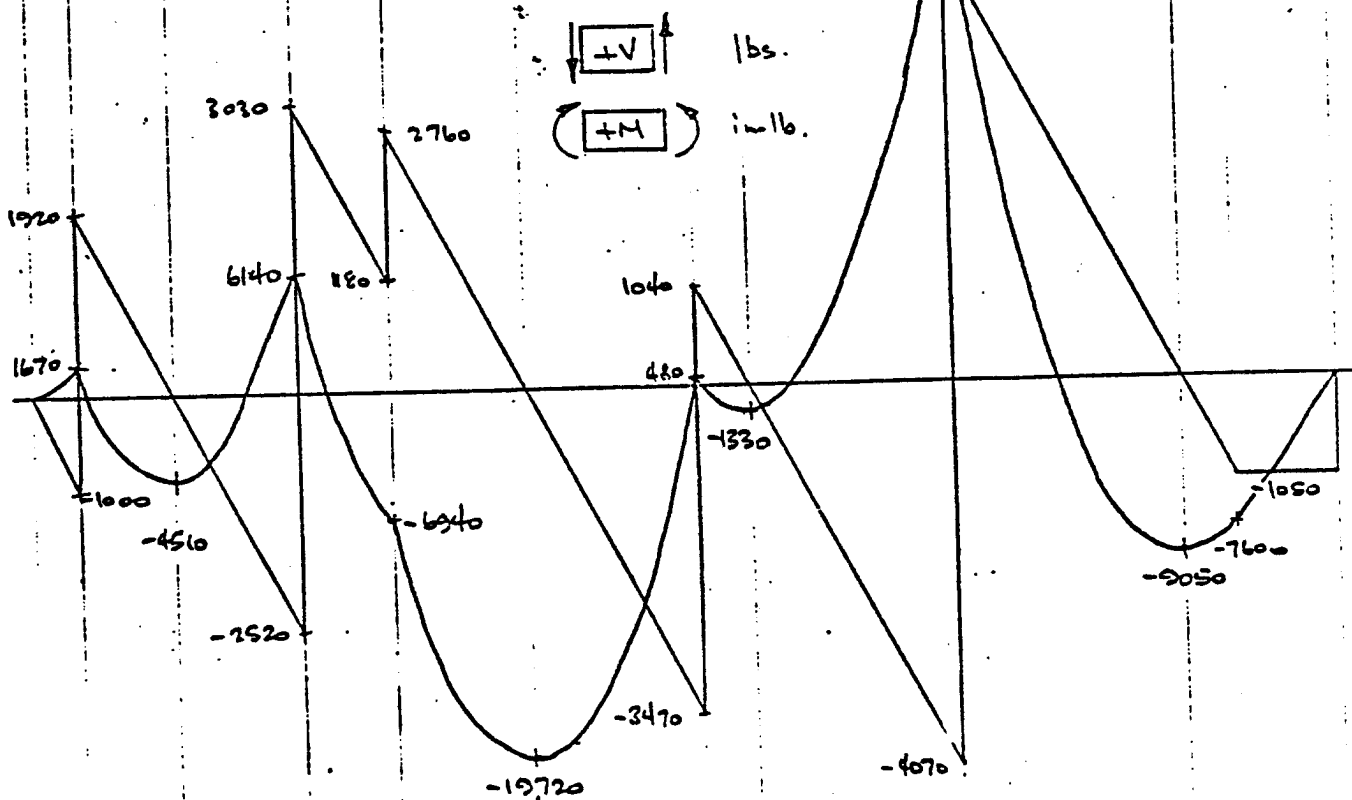
FIGURE 7-10

AFT INBOARD FLAP SHEAR AND MOMENT DIAGRAM

The fatigue loads spectrum shown in Table 7-1 was used in the fatigue analysis. The shear, moment, and torsion diagrams used are shown in Figures 7-10 and 7-11. The life goal was 15 years or 15,000 hours of foilborne operation. A fatigue reliability factor of 1.0 was used. The fatigue life estimates were based on 95 percent probability of survival and that a typical failure would occur at four (4) times the 95 percent life. A summary of the fatigue lives calculated for the metal details is shown in Table 7-2. All are more than sufficient to meet the predicted PCH-1 hydrofoil flap requirement of 200 hours service exposure. A few areas are shy of the design life requirements of 15,000 hours specified for production hardware. This was essentially caused by the requirement which specified that the composite flap must be interchangeable with and remain within the envelope of existing steel flap. The areas which are shy are in the crank and will be blocked-up and fixtured in a manner which will permit the loads to bypass them and allow the flap to attain its design life goals. The fatigue analysis supporting the life data summary shown in Table 7-2 was previously summarized and transmitted in Document D180-24630-1, "Development of an Advanced Composite Hydrofoil Flap - Phase II Final Design", Contract Number N00024-76-C-4233.

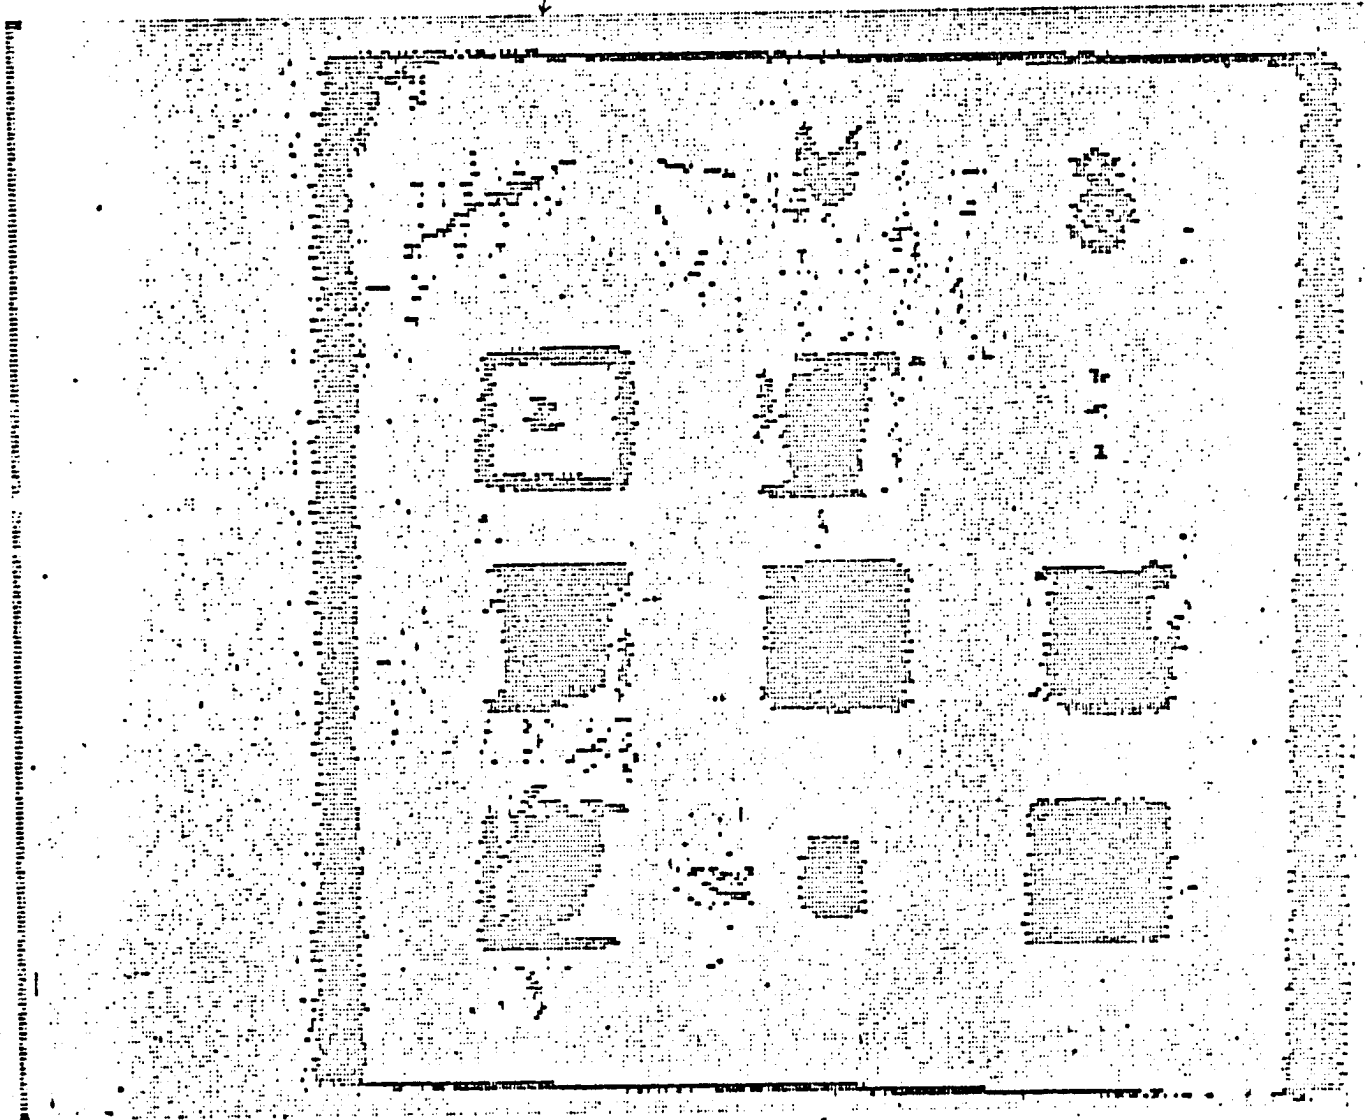
FIGURE 11-2 THROUGH TRANSMISSION ULTRASONIC RECORDING

CHARACTERS 1-9 SUPPRESSED  
 TO REVEAL AREAS WITH HIGHEST  
 ATTENUATION.  
 THROUGH-TRANSMISSION

TOTAL NUMBER OF BLOCKS = 439 3MHz - 6.6 DETECTOR

The results of the above tests are summarized in Table 11-1. A positive indication of the flaws is noted by an "X" in the table. As noted from this data, the through transmission ultrasonic technique provided the best flaw detection capability.
